Spain Actuator Testing and Results

Actuator I Session

17 July 2013 | DESI Berkeley Meeting

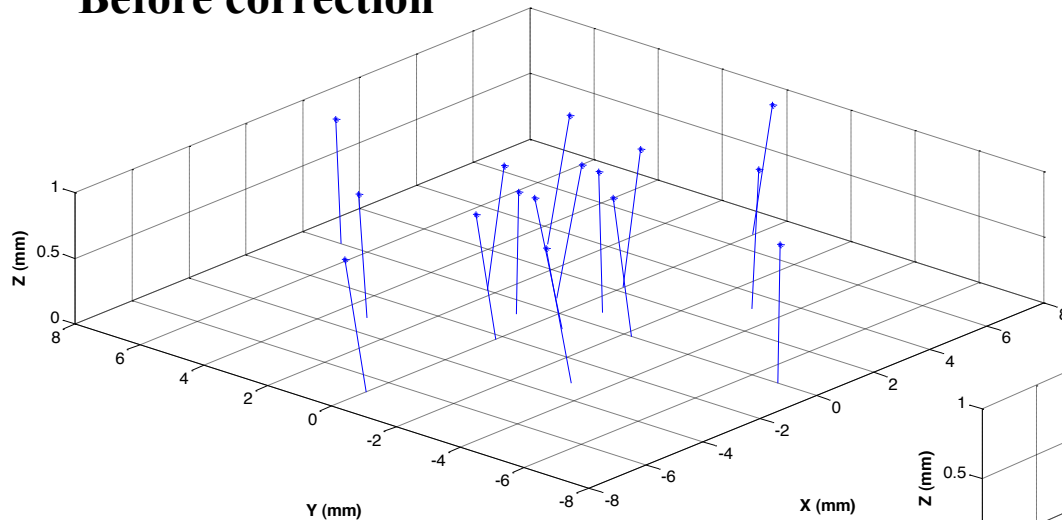
Normal Vector (x 100)
Before correction

Tilt versus Location

- The mirror was tilted 0.32° to the axis
- Before correction the maximum tilt was 0.36° ; average = 0.322° ; RMS= 0.032°
- **After Correction the maximum tilt was 0.06° ; average = 0.035° ; RMS= 0.019°**

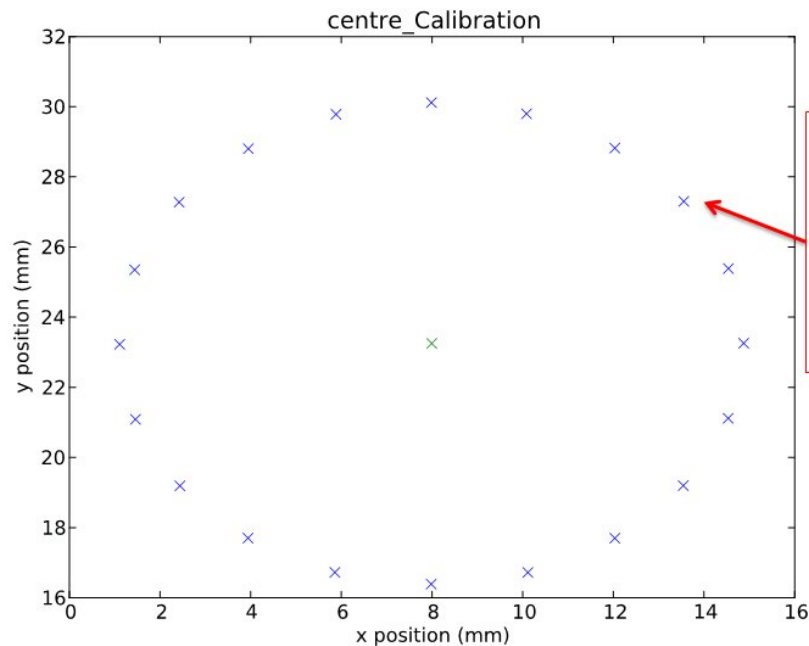
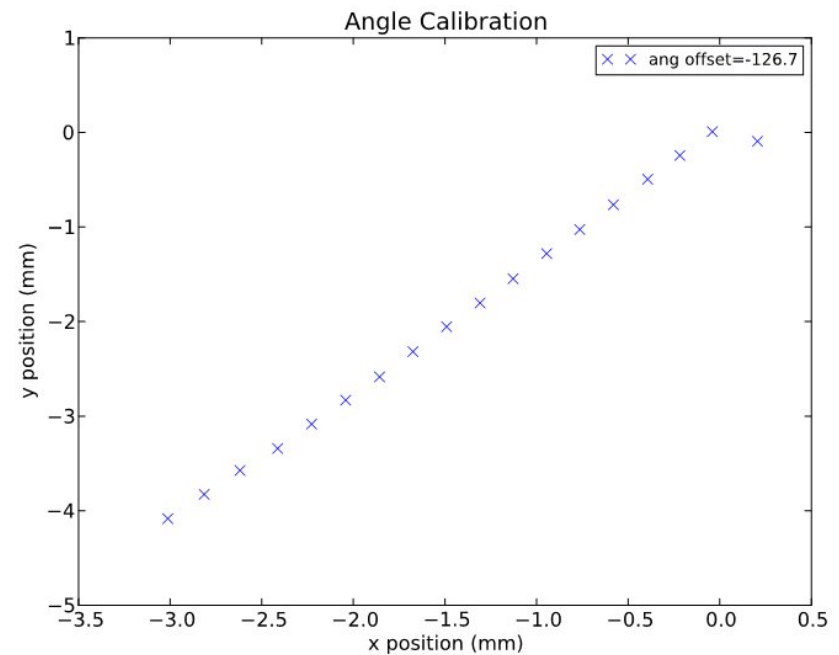
- Testing procedure
 - Calibration find center
 - Calibration find angle
 - Grid of targets

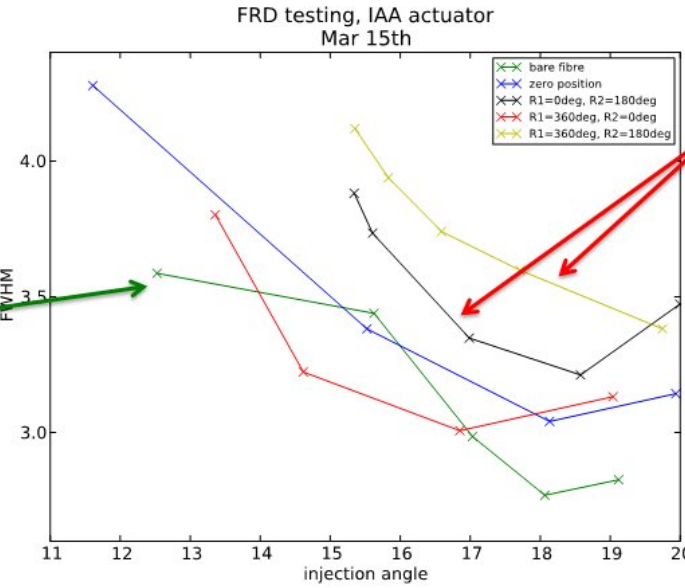
- At f/3.5, increase in FWHM is ~0.5 degrees, a single splice is ~0.2 degrees for comparison
- This shows that the design needs to be updated in order to minimize FRD
- Furcation tube to protect fibre

Extremely poor fibre – without actuator FWHM~3.5 deg! Still can be used to indicate trends

Worst performance at R2=180deg -this is where fibre touches shaft

- The design needs to be updated in order to minimize FRD
